TRONOX KZN SANDS

HILLENDALE MINE

EXTERNAL AUDIT OF EMPR

Audit Findings and Summary Report

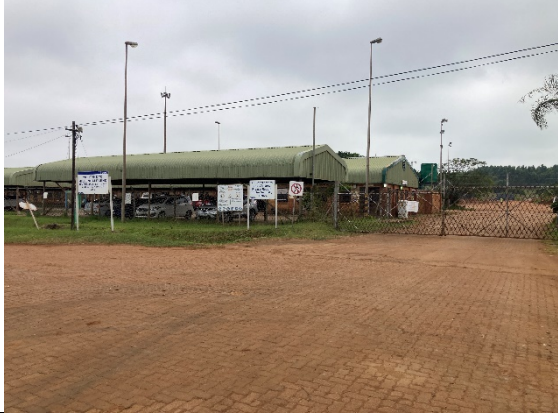
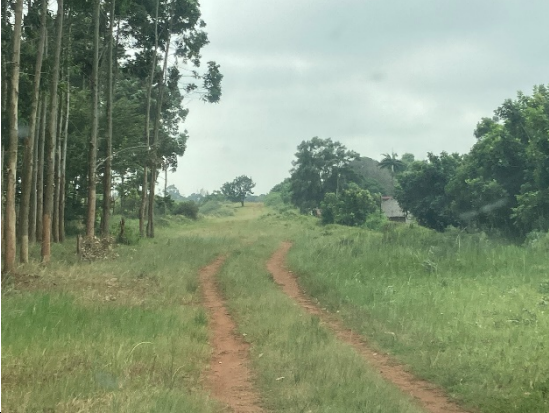
<p>Main Offices that will be transferred to the South African Police Services should third party negotiations during the closure phase be successful.</p>	<p>Vegetation cover is well established on site and ongoing rehabilitation is taking place.</p>

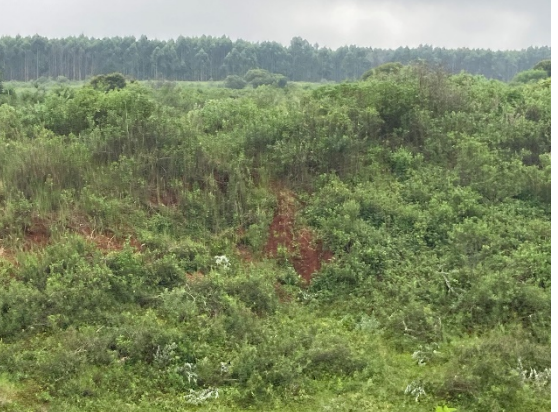
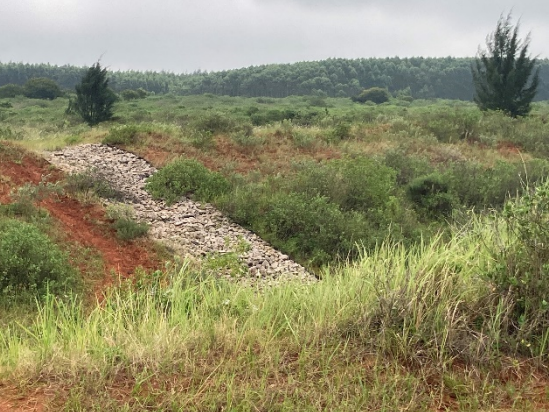
<p>Old mining areas which have been shaped and rehabilitated to natural vegetation.</p>	<p>Maintenance of drainage infrastructure from mining areas is ongoing on site and all drains are well maintained and free flowing.</p>

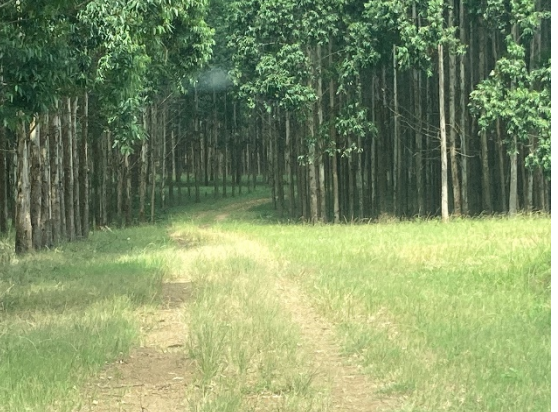
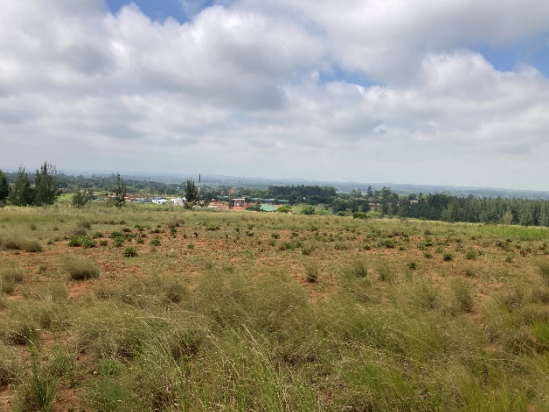
<p>Eucalyptus tree trials which were undertaken as part of site rehabilitation are successfully growing on rehabilitated mining areas.</p>	<p>Grasslands on previously mined areas on site. The site is extensively grazed by community cattle and goats.</p>

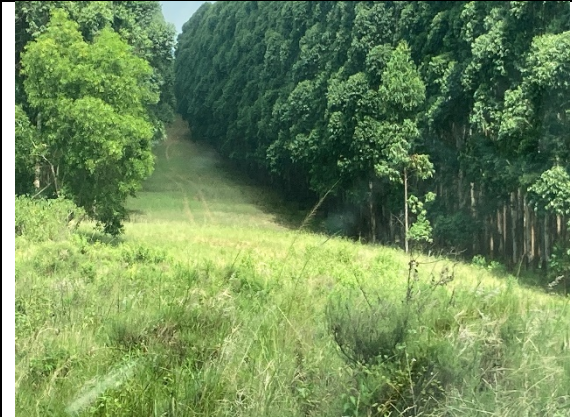
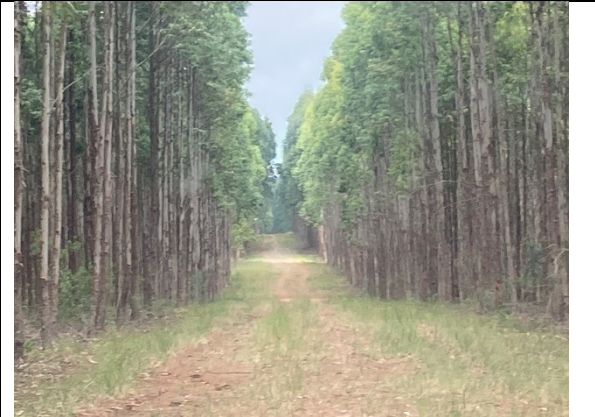
<p>Eucalyptus tree trials which were undertaken as part of site rehabilitation are successfully growing on rehabilitated mining areas.</p>	<p>Access roads through the Eucalyptus plantations are well maintained and provision for drainage infrastructure has been made.</p>

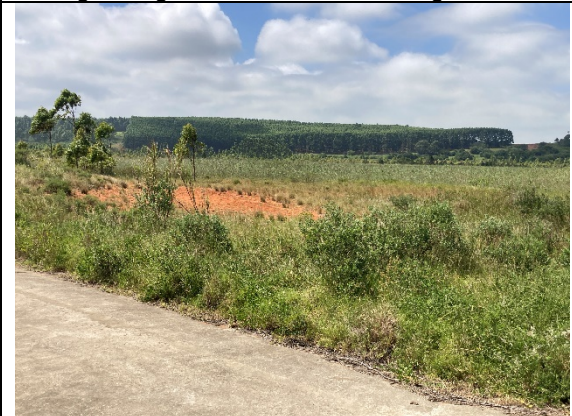
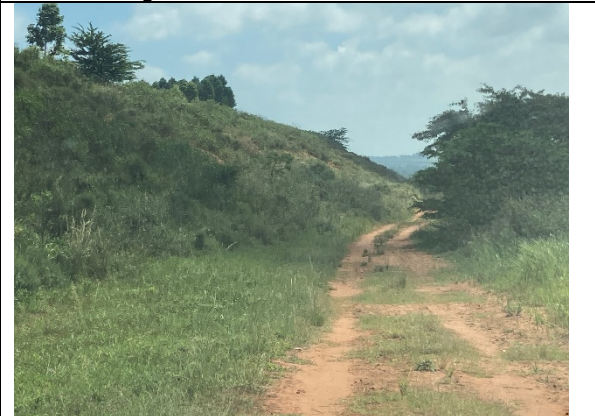
<p>The residue storage facility which is drying out and trees and natural vegetation is becoming well established.</p>	<p>Banks around the RSF are well maintained and no signs of erosion are visible on the embankments.</p>

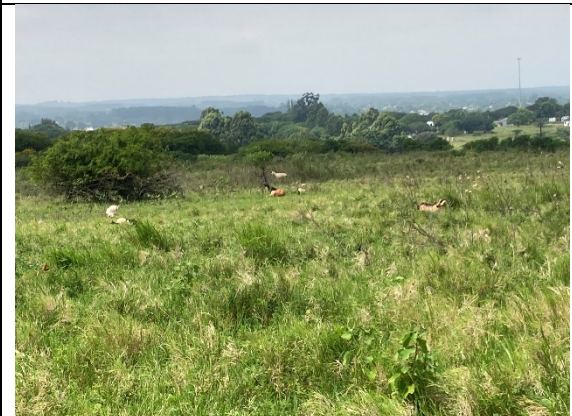
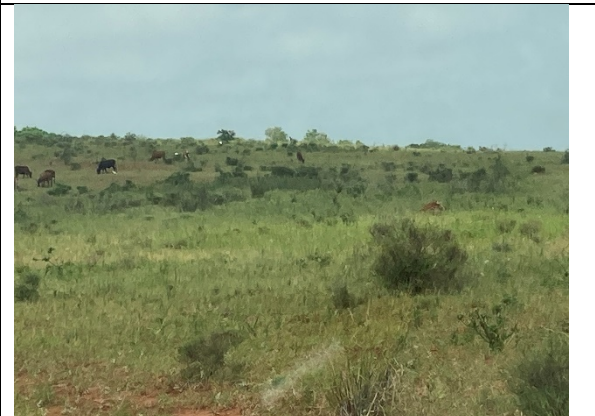
<p>Rehabilitated mining area with goats grazing on the natural vegetation becoming established.</p>	<p>Rehabilitated mining area with dense natural vegetation becoming established.</p>

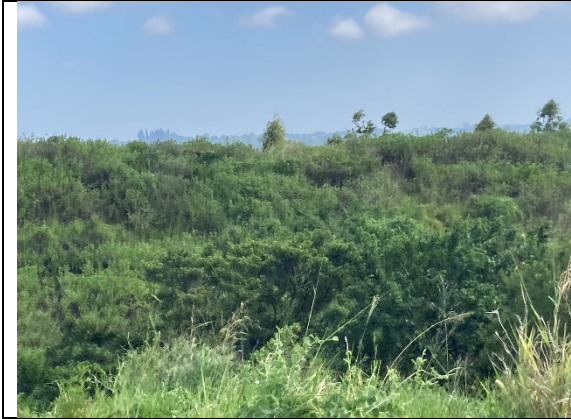
RSF return water dam which has been decommissioned and rehabilitated.

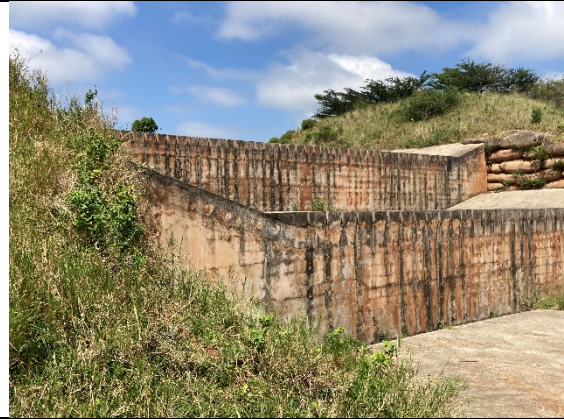
RSF spillway which is well maintained and fit for purpose.
